Intel[®] 80314 I/O Processor Companion Chip

Specification Update

March 2005

Order Number: 273759-008US

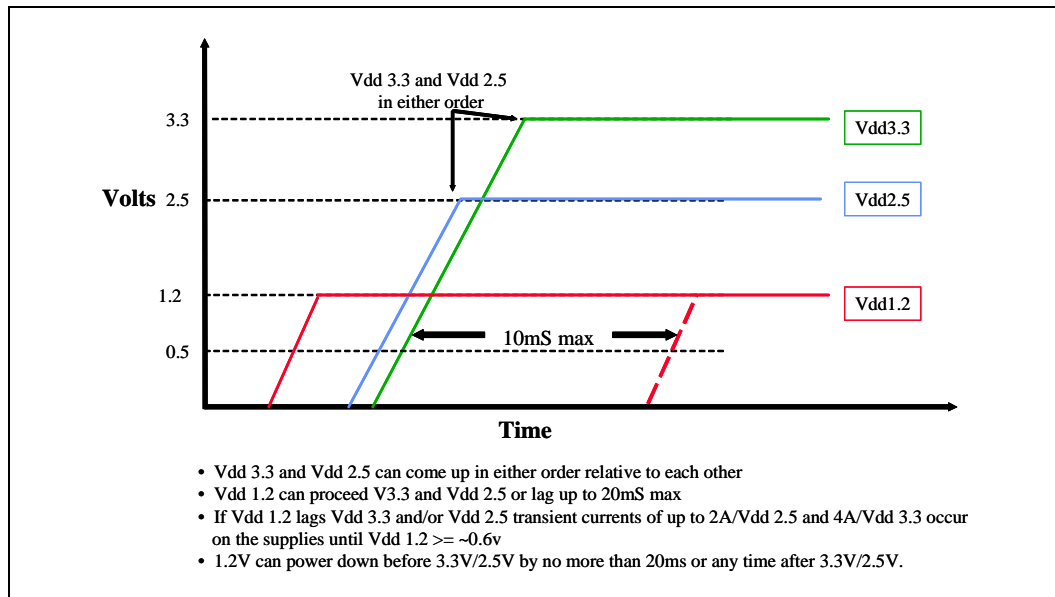
Figure 1. Power-Sequencing Requirements

Issue: The power-up and power-down sequences of the 80314 1.2 V/2.5 V/3.3 V supply rails has been revised from version 003 and 004 of this specification update. The power sequencing requirements initially presented in version 003 were designed to avoid transient current draw that could appear on the 2.5 V/3.3 V supply rails. Further investigation has determined that no current transients occur when the 1.2 V supply is ramped first. In addition, it is acceptable to ramp the 1.2 V supply after the 2.5 V and 3.3 V supplies as long as the lag is less than or equal to 20 mS. When the 1.2 V rail lags the 2.5 V and/or 3.3 V rail, transient currents of up to 2 A/V_{DD2.5} and 4 A/V_{DD3.3} can occur on the supplies until V_{DD1.2} >= ~0.6 V. The 1.2 V supply can power down no more than 20 ms before or any time after the 3.3 V/2.5 V supplies power down. These requirements are illustrated in [Figure 1](#).
